## SPECIAL NOTES

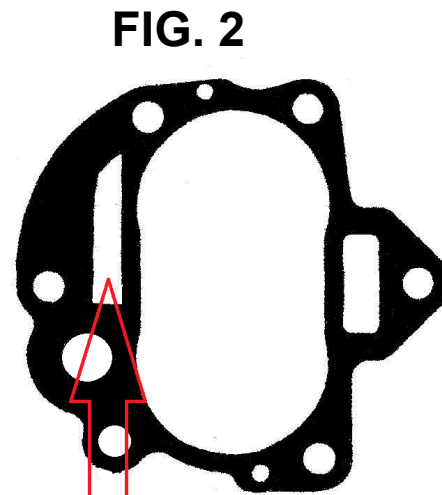
**DO NOT USE GASKETS  
THAT LACK THIS OPENING**

The slot shown in **Figure 2** must be in the gasket for this system to work. Some replacement gaskets do not have this slot.
