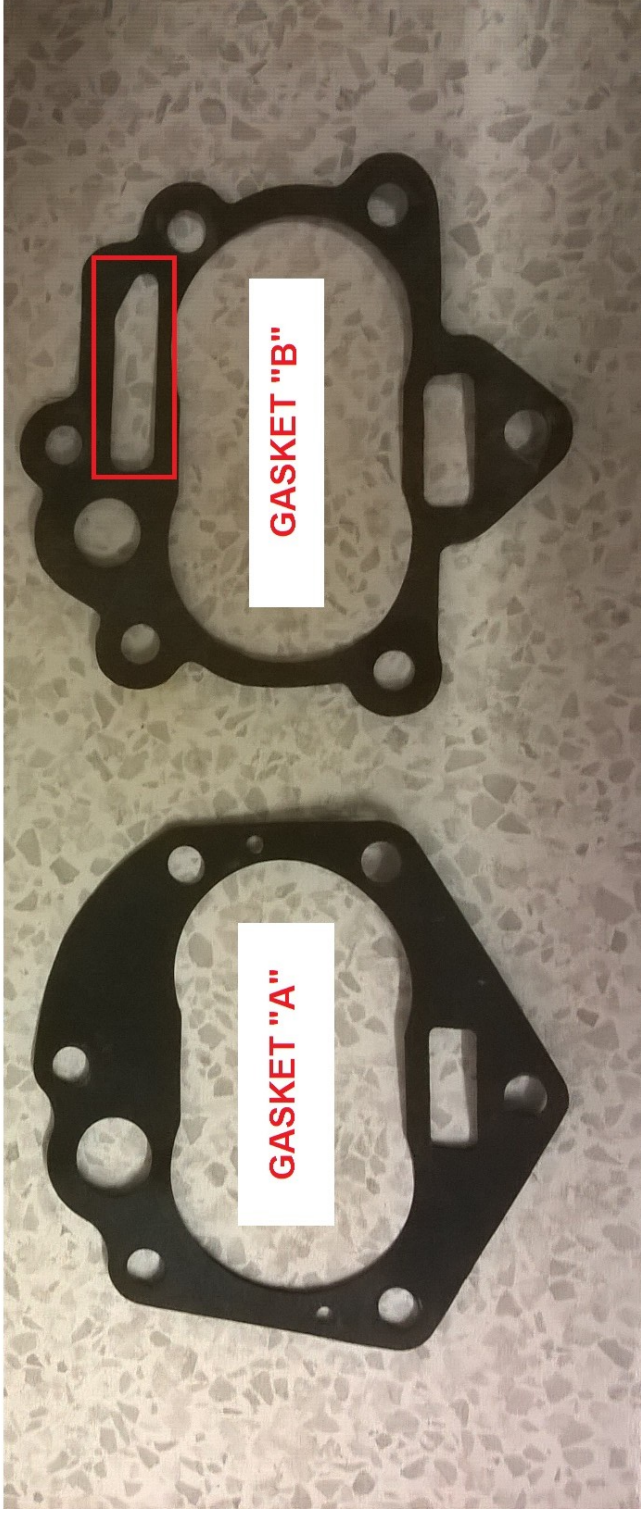
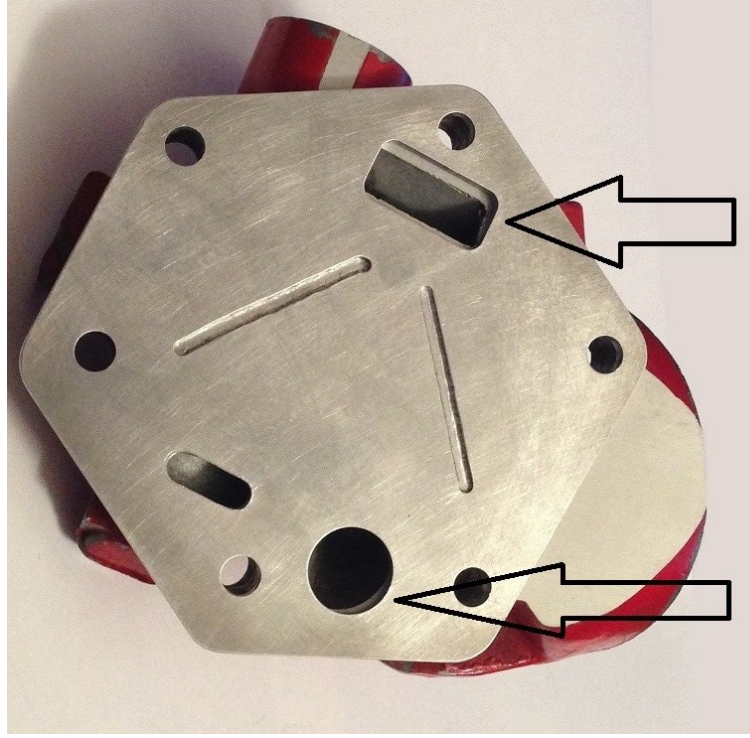
**DO NOT USE GASKET "A"
THAT DOES NOT HAVE
PASSAGE LIKE GASKET "B"**

ON EITHER SIDE OF PLATE
